Dowden's Luck
Property Name

United States Department of the Interior
National Park ServiceNational Register of Historic Places
Registration Form

historic name Dowden's Luck
other names/site number Ellerslie or Wallace Poole Farm M: 17-20

United States Department of the Interior
National Park ServiceNational Register of Historic Places
Continuation SheetDowden's Luck M: 17-20
Montgomery County
MarylandSection number 7 Page 1GENERAL DESCRIPTION:

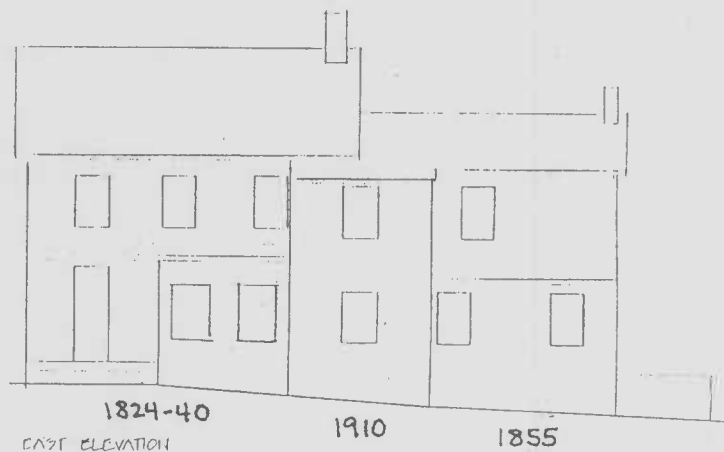
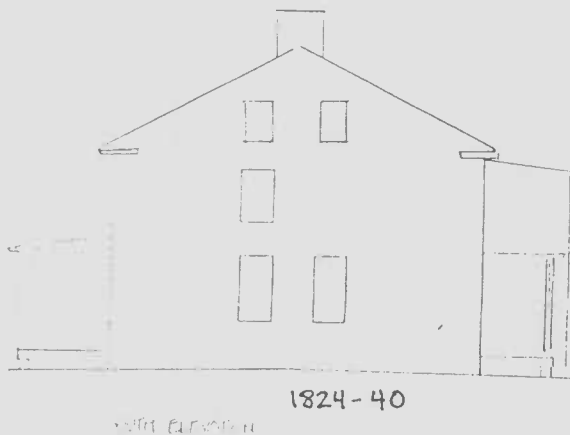
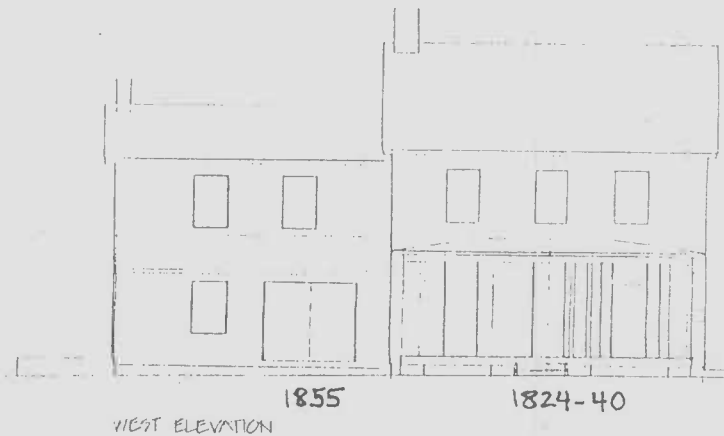
"DOWDEN'S LUCK"
Montgomery County, MD
South, East, West Elevations
Main Dwelling

The main block of the residence, 30 feet by 32 feet, built between 1824 and 1840 is constructed in the late Federal style of the Early Republic Period. It is three bays wide, two and a half stories high with low pitched gable roof, and interior end wall chimney. Across the front there is a hipped roofed veranda-type porch with posts trimmed in gingerbread, Gothic Revival Style and bracketed cornices in an Italianate Style. This is an 1855 addition to the main block. The windows of the main block are six over six pane with large lights and thin muntins. On the front, two windows have molded and paneled moveable aprons which open inward. The large 6-panel front door is surrounded by vertical wooden panels on each side, sidelights and transom lights. Extending across the East facade of the main block there is a wooden porch with a slightly slanted roof supported by 3 chamfered 4" x 4" wooden posts. The bay window of the back parlor projects on to this porch. Two Seneca sandstone steps lead from the porch to the garden.

The walls of the house are constructed of timber framing filled with brick nogging and covered with 6 to 8 inch wide weatherboarding. The exterior was covered in the 1950's with asbestos shingles. The weatherboarding and their corner boards are visible in some places where the shingles have been removed. The wood shingle roof is covered with asbestos shingles.

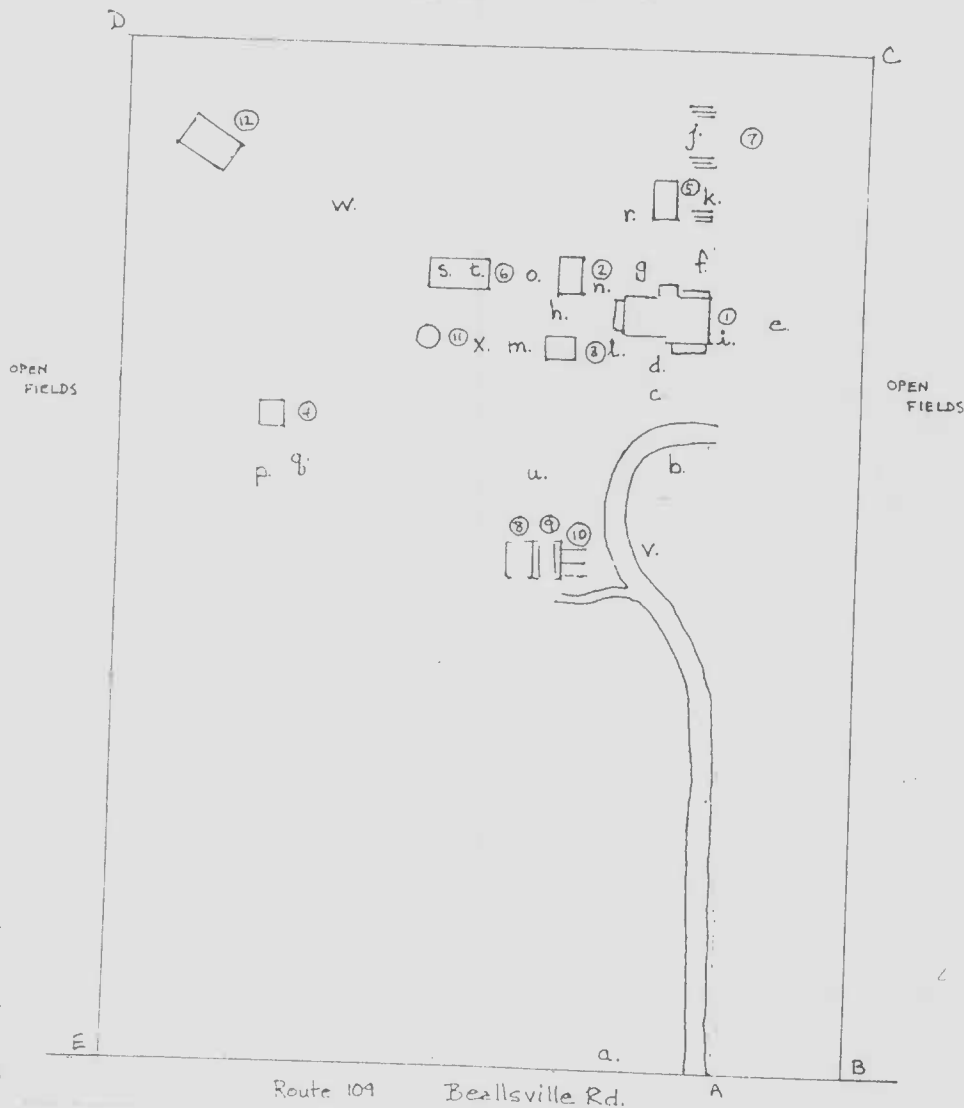
PHOTOGRAPH MAP

r.	37	Foundation of back building, 1824-40, northwest corner.
s.	39	Foundation of 'Switzer barn' 1824-40, from interior, w/s walls.
t.	40	Foundation of 'Switzer barn', s. well, built in shelves & timbers.

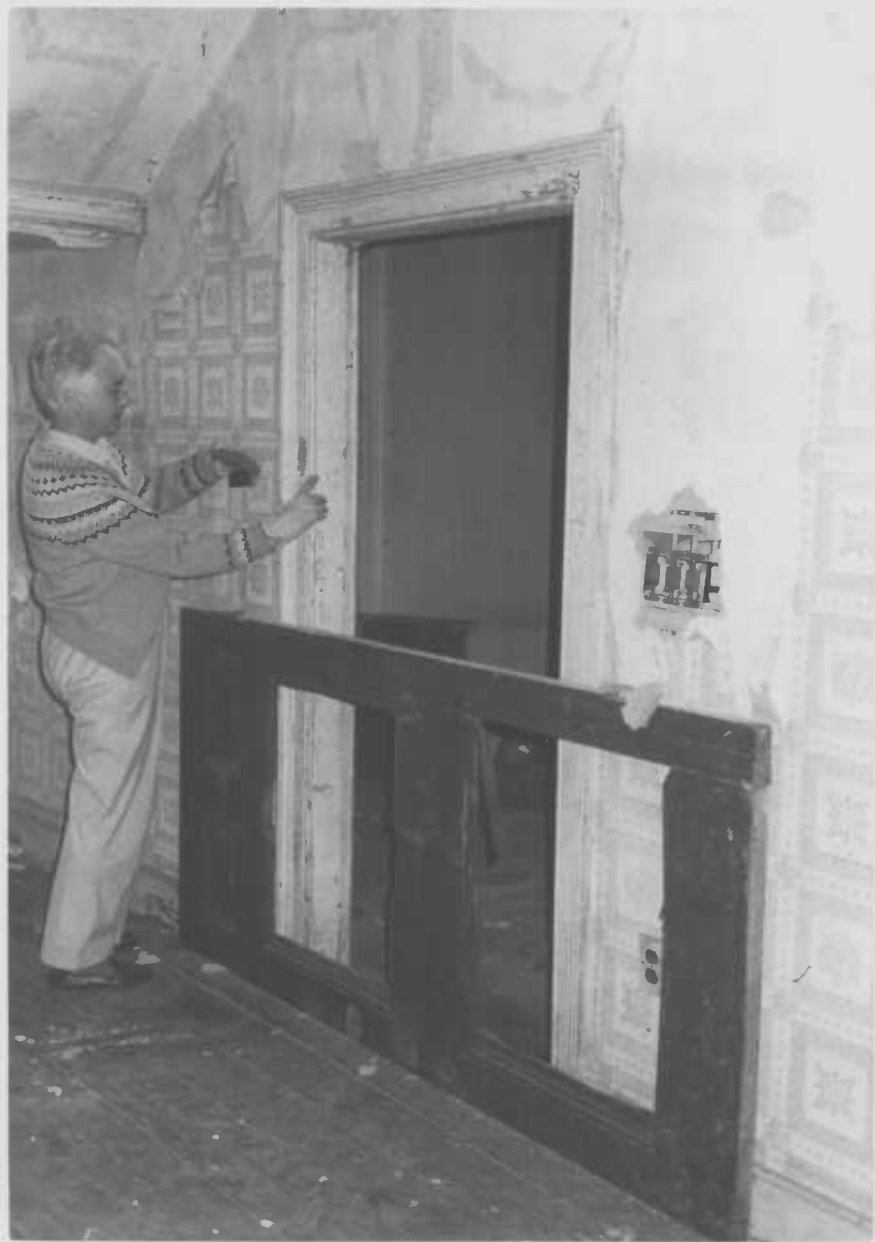
12A ^{sf} slide 14 of 39

One of two doorways in this wall.

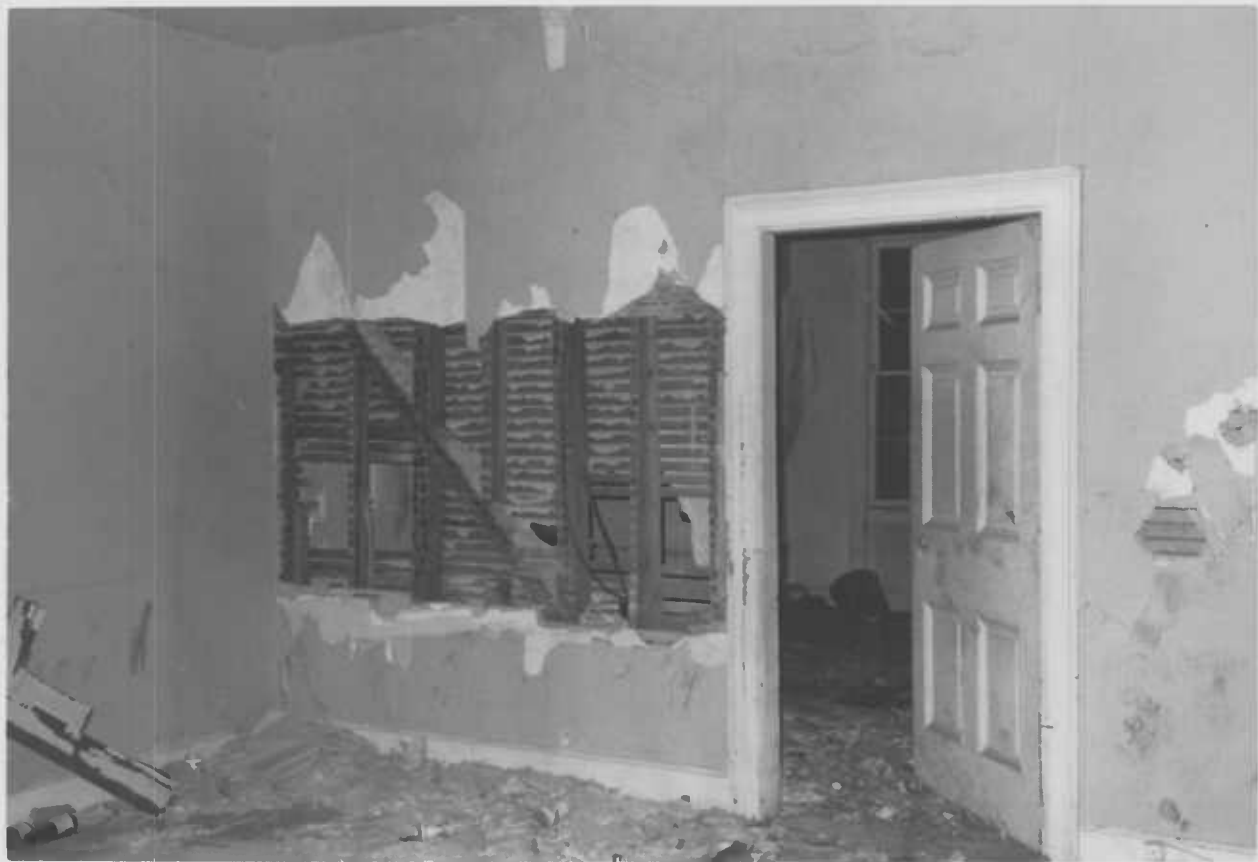
15A SLIDE 19 of 39

West wall of back parlor showing woodwork
and six-panel door.

Opening from the left side of the entrance hall there are two parlors, front and back, each with fireplaces, whose mantels have been removed. The wooden trim of the architraves are cyma reversa combined with flush bead molding and two fascias in a 4 1/2" band. The doors are molded six panel doors. Ceilings are 9 ft. Floorboards are 6 1/2 to 8 inches wide. The front parlor has the apron windows mentioned earlier. The back parlor has a late addition of a bay window consisting of four fifteen-pane windows facing the back, (East). In this parlor there is an original cupboard built into the chimney and two doorways to the North wing of the house.

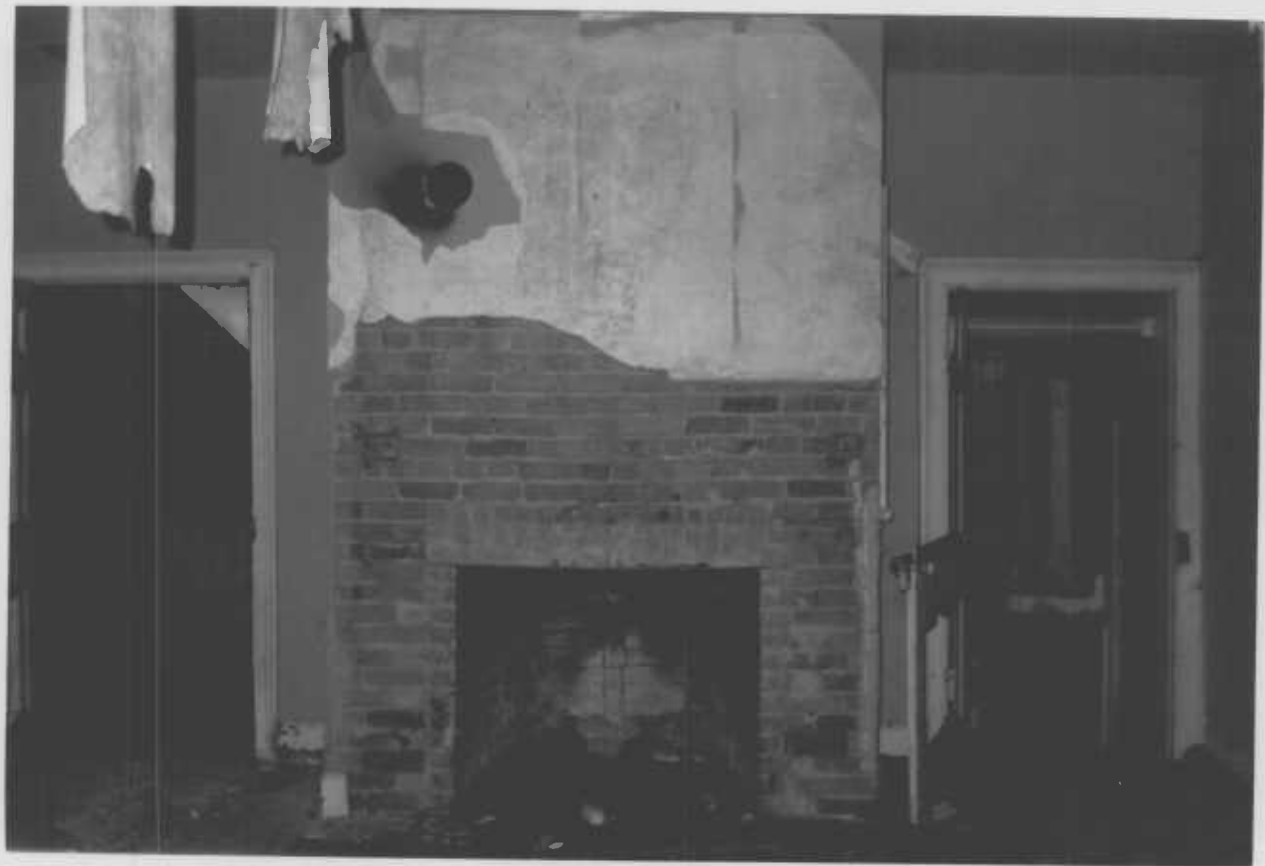
15B ^{OF} SLIDE

Back parlor, North wall, fireplace mantle
missing, closet in back of mantle, damaged
six panel doors

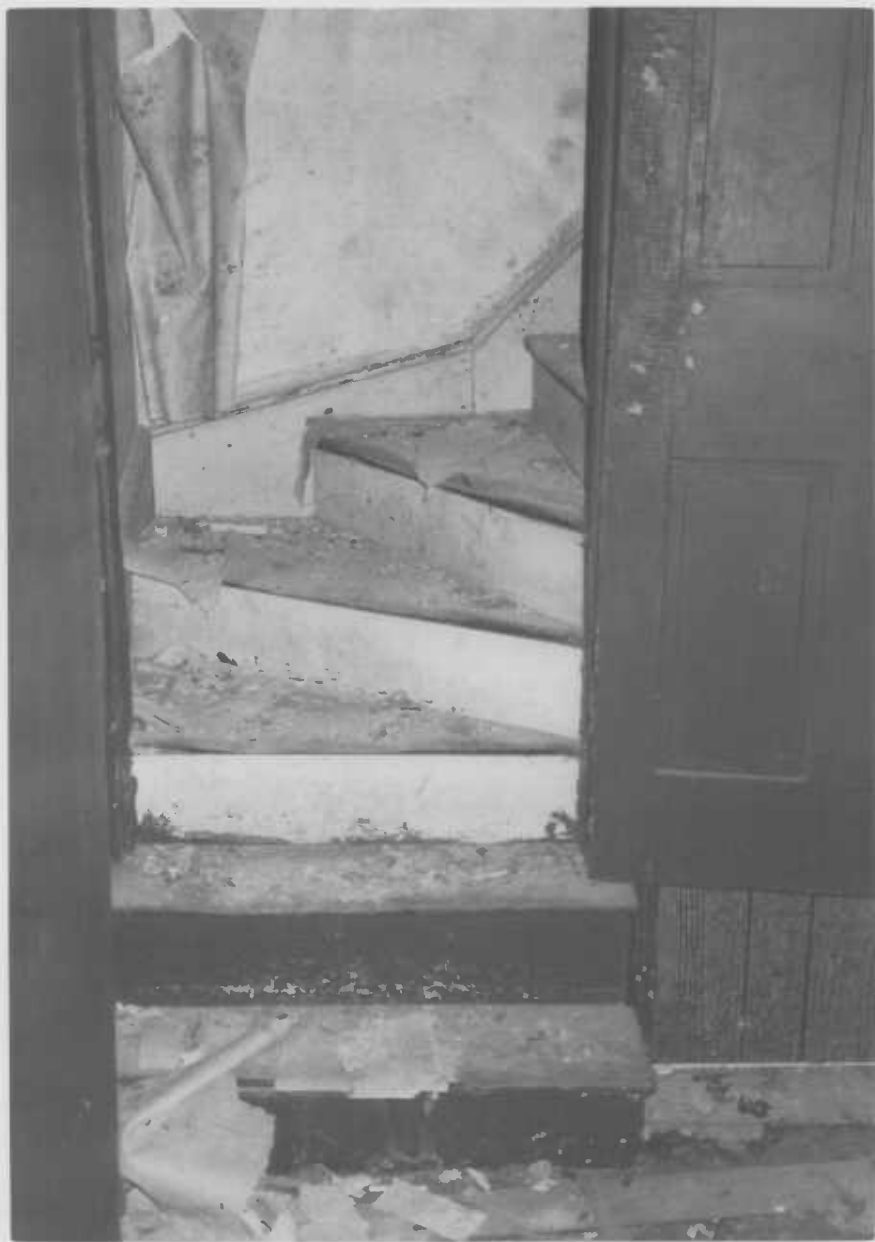
17 SIDE 220739

Closed staircase on South wall of 1855
addition leading to bedroom directly above
dining room.

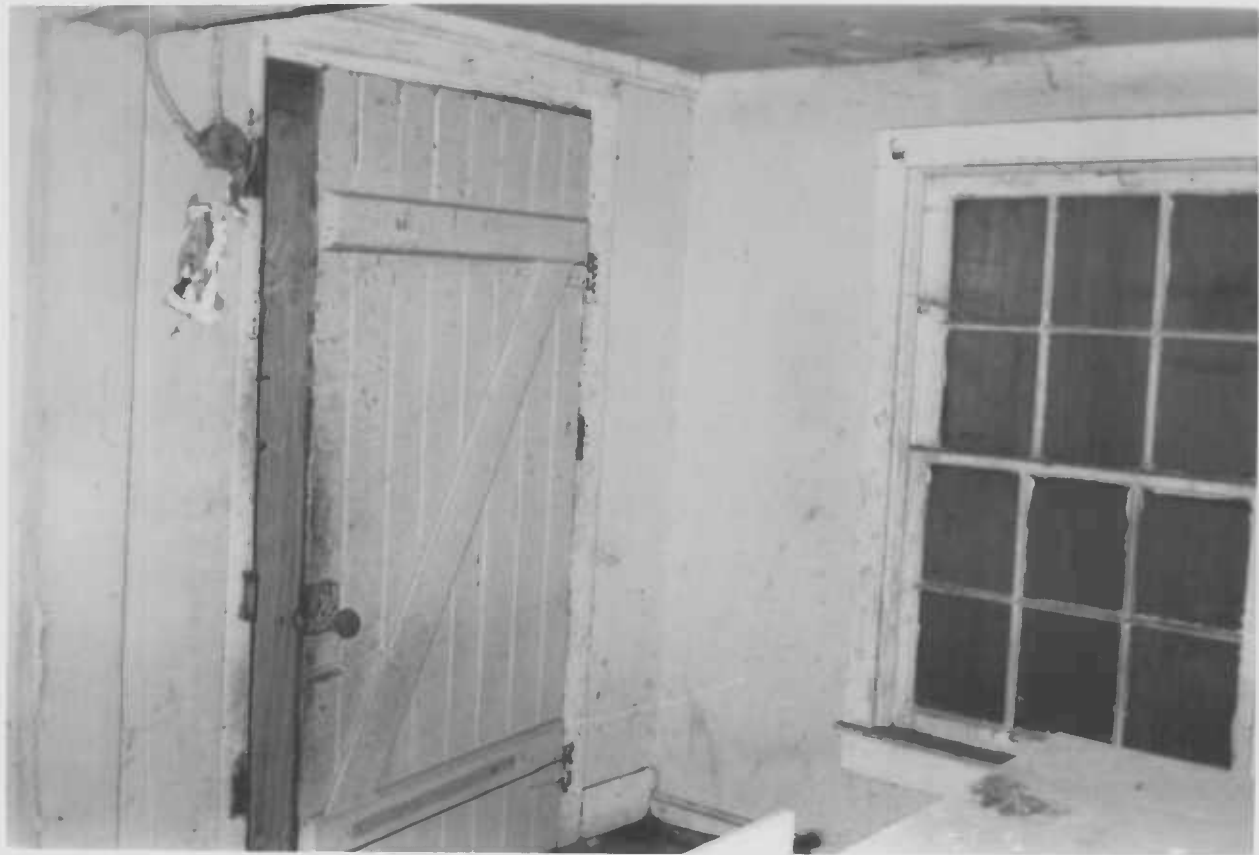
18 SLIDE 24739

Kitchen interior, Northeast corner

The first floor of the addition contains a dining room, kitchen, pantry and small back hall.

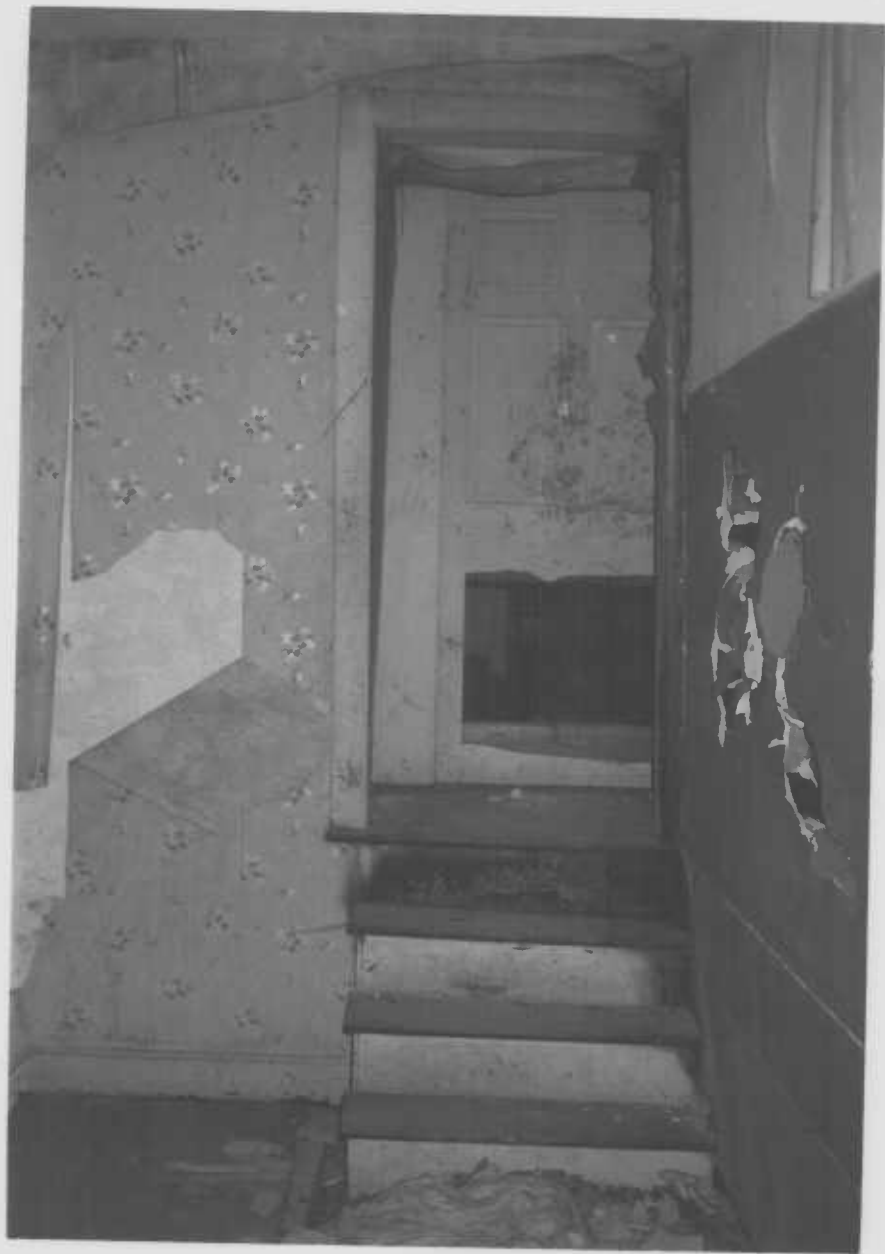
26739

Steps to 1855 bedroom from 1824-40 main
block. Interior, second floor
of

The second floor of the 1955 wing is at a level two steps below the second floor of the main block. One bedroom extends north-south from the wall of the main block to the gable end of the addition. In the end wall there is a fireplace, with a mantel which matches the dining room mantel, set between the back of another chimney and a built in closet. A small stairway with rounded hand rail and square balusters at this level, descends to the dining room below. The room is lighted by two six over six windows facing west and one facing east.

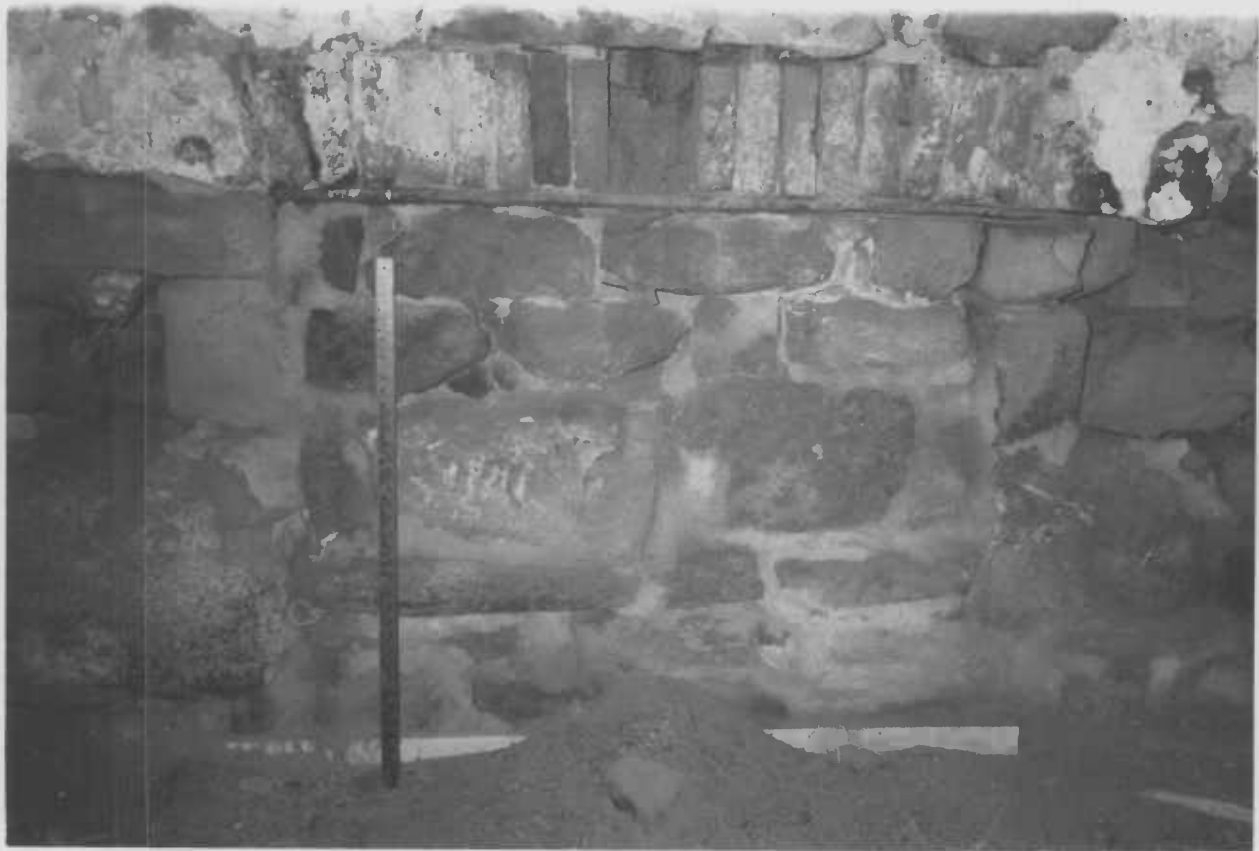
32 ~~SLIDE~~ 34 n 39

Slave quarter, interior, West wall,
fireplace filled with rubble stone

On the interior, two rooms are divided by a vertical-board wall containing one door. The walls are plastered, the three windows deeply recessed. A stone fireplace in the west end of one room has a brick lintel and no mantelpiece. The opening is filled with rubble stone. There is no ornamentation on windows or doors. Architraves are made of flat boards. The two steps leading from the entrance on the exterior are two large flat stones.
